NAME OF AUTHOR MICHEL PIERRE COMEAU
TITLE OF THESIS FATIGUE STRENGTH OF WELDED STEEL
 ELEMENTS
DEGREE FOR WHICH THESIS WAS PRESENTED MASTER OF SCIENCE
IN CIVIL ENGINEERING
YEAR THIS DEGREE GRANTED FALL, 1979

FATIGUE STRENGTH OF WELDED STEEL ELEMENTS

This investigation was conducted in two phases. In the first phase the fatigue behavior of fifteen steel beams with welded attachments was studied. In the second phase the fatigue behavior of four HSS trusses with welded connections was examined. Throughout the study the research findings were compared to the fatigue provisions of the Canadian Standards Association Standard S16.1-1974.

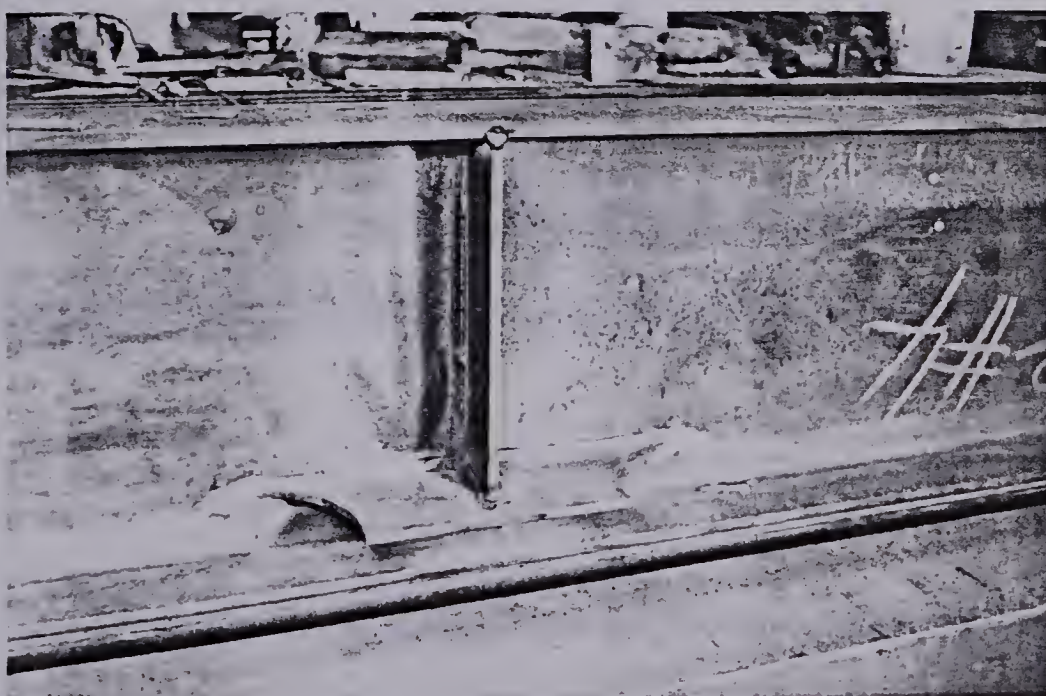
Figure 3.2 Circular Transition Bracing Attachment

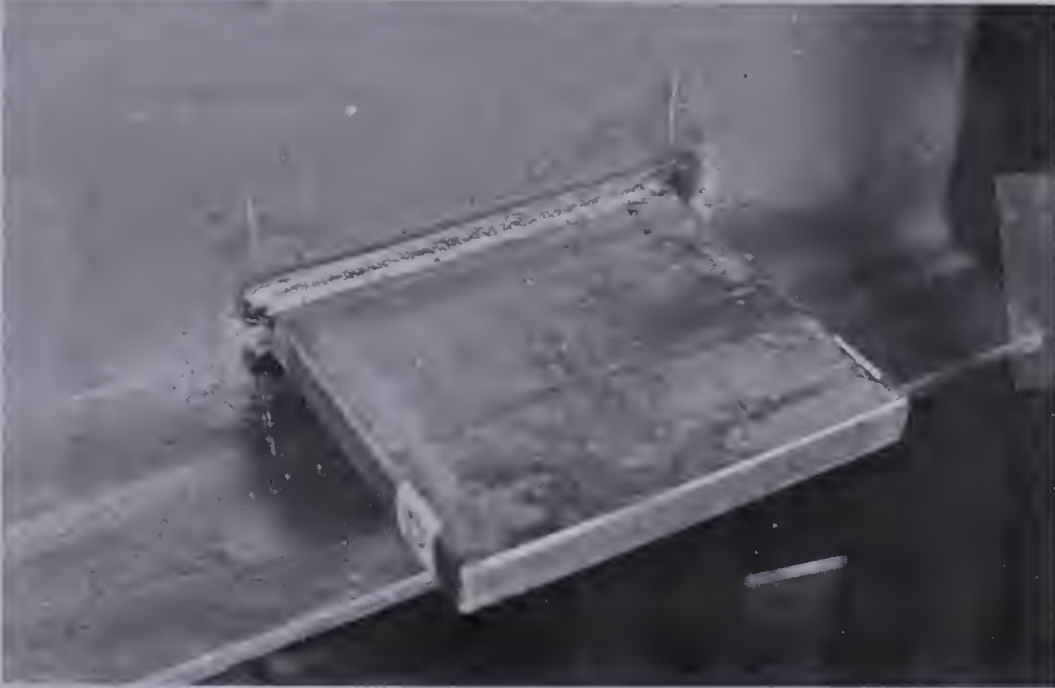
Figure 3.6 Crack at End of Tapered Attachment

The crack initiation and growth patterns for specimens 1T and 2T were quite similar. Cracks initiated in the fillet weld at the end of the horizontal gusset with one crack appearing at each end of the gusset for each specimen. The cracks grew vertically upward and downward from the initiation site in the beam web.

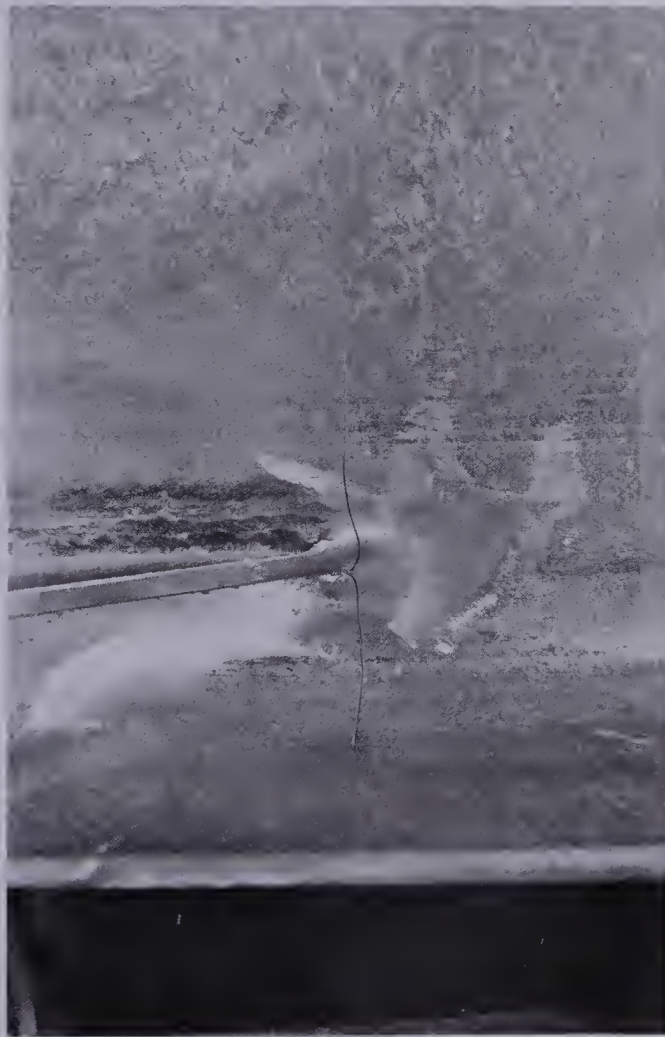
Figure 3.5 Beam With Plate Intersecting the Web

In addition, as part of Phase I, six beams were tested in which plates intersected and passed through the web of the test beam as shown in Figs. 3.5 and 3.7 (specimens 1W to 6W). The purpose of these tests was to simulate the conditions created when an intersecting member must pass through, and/or be welded to, a beam web at right angles. This may occur particularly in large plate girder or box girder structures, and also in some floor beam flange to girder web connections. Three of the beams investigated had an intersecting plate to web thickness ratio of 2.51 (specimens 1W, 2W and 3W) and three had an intersecting plate to web thickness ratio of 3.26 (specimens 4W, 5W, and 6W). In all six cases the thickness of the intersecting plate was 3/4 inch.

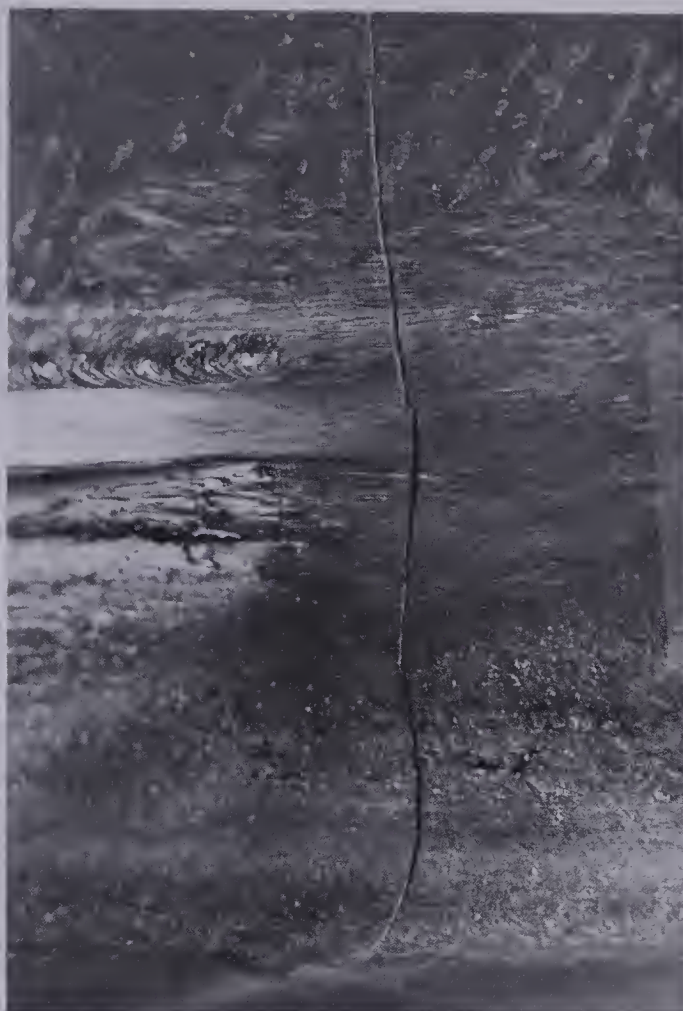
Figure 3.8 Crack at End of Circular Transition Attachment

In the RG test series, cracks initiated at flaws in the weld at the end of the horizontal gusset. In all eight cracks observed, the cracks originated at slag inclusions and/or gas pockets in the weld. No cracks initiated at the location where the actual weld toe had been present prior to grinding. All cracks grew vertically upward and downward simultaneously from the initiation site. This is shown in Fig. 3.8.

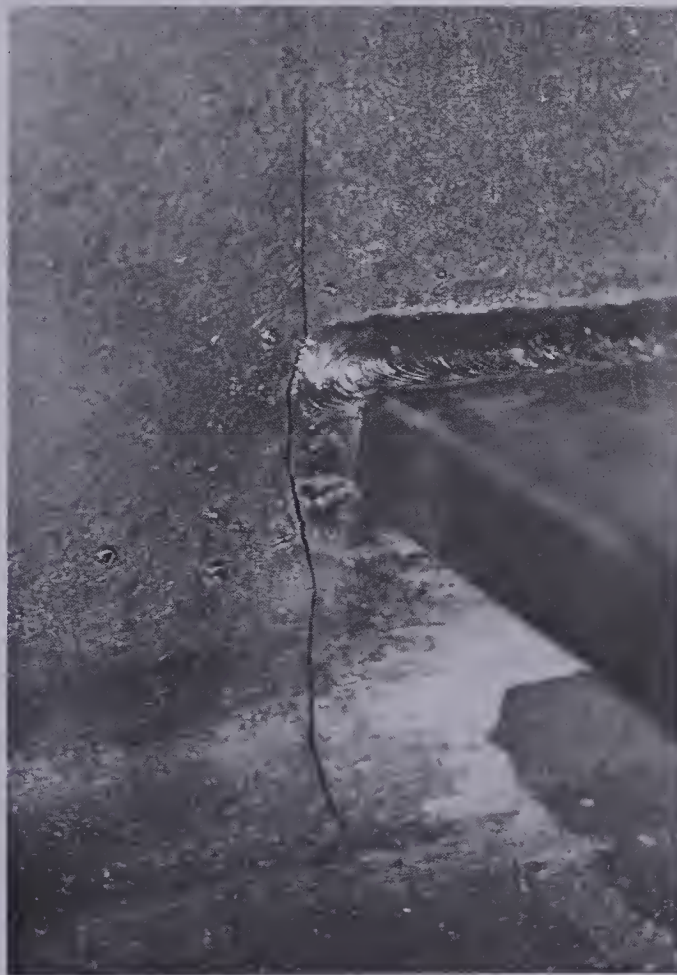
Figure 3.17 Crack in Beam With Plate Piercing Web

All beams tested in this series (W series) failed as a result of fatigue cracks which initiated at the toe of the fillet weld at either end of the plate piercing or butting against the beam web. Cracks grew vertically upward and downward from the initiation site in the beam web. One crack, typical of the type observed in these tests, is shown in Fig. 3.17.

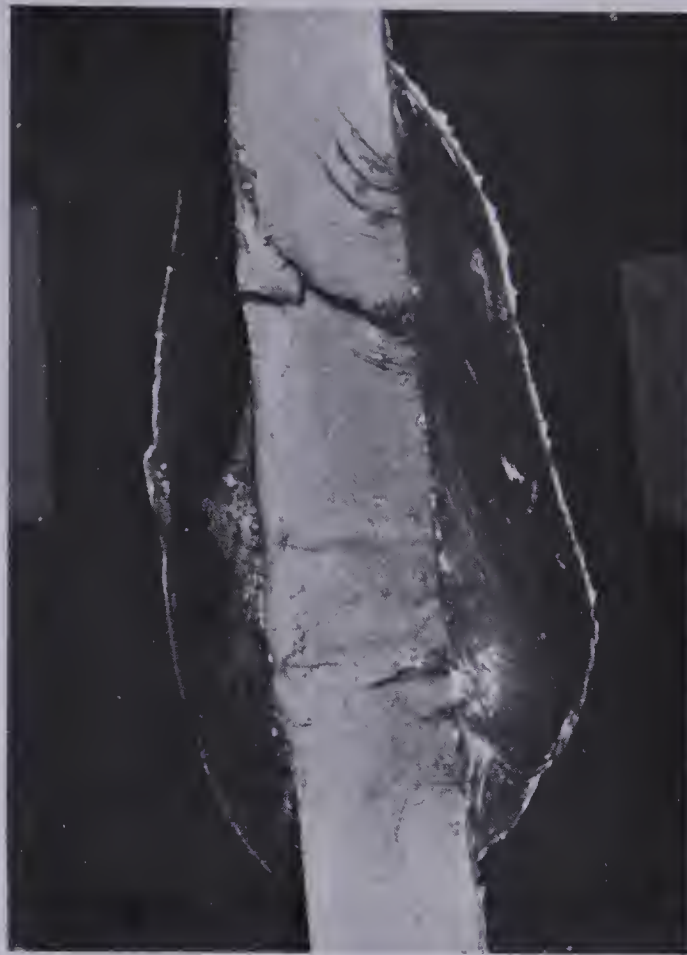
Figure 3.18 Fracture Surface of Crack

As stated above, all cracks causing failure initiated at the toe of the fillet weld in the beam web. No slag inclusions were observed in any of the crack surfaces which were opened up. Some of the crack surfaces had a stepped appearance as shown in Fig. 3.18. This relief in the crack surface results when cracks initiate at more than one flaw simultaneously. These individual cracks then merge and propagation continues on a single crack front.

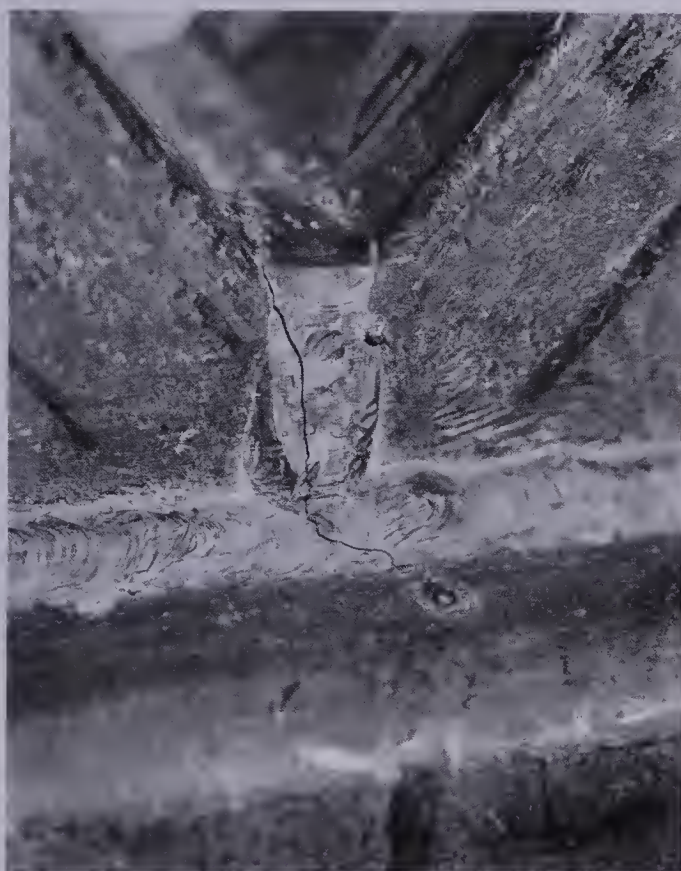
Figure 4.5 Crack at Joint L1

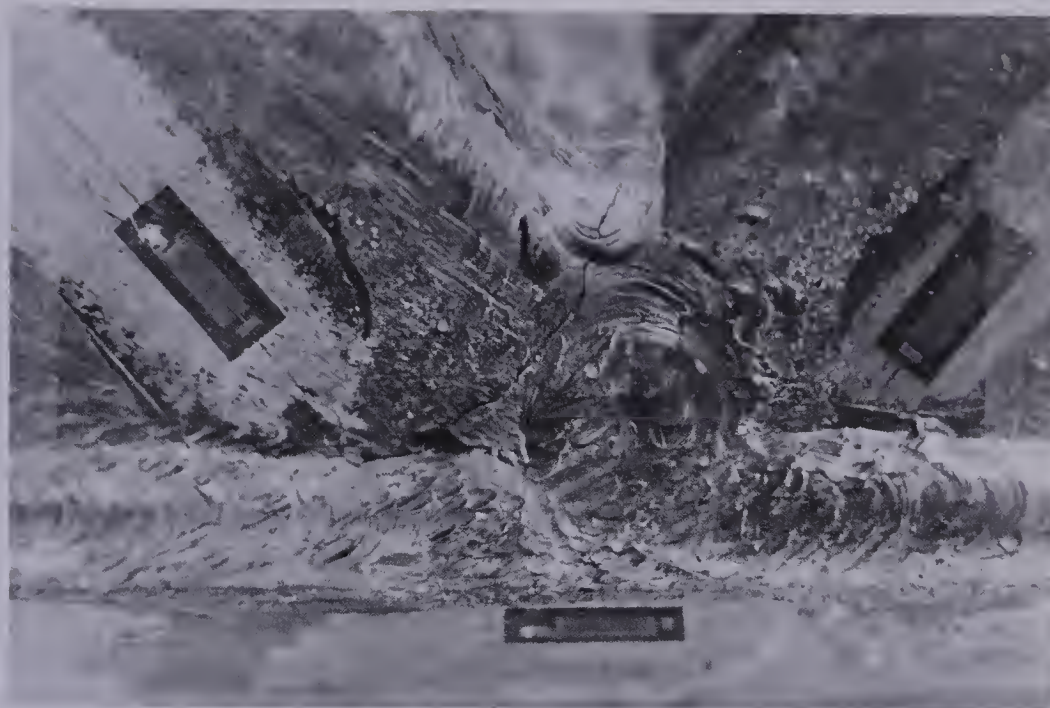
Figure 4.6 Crack at Joint L1 (opposite face)

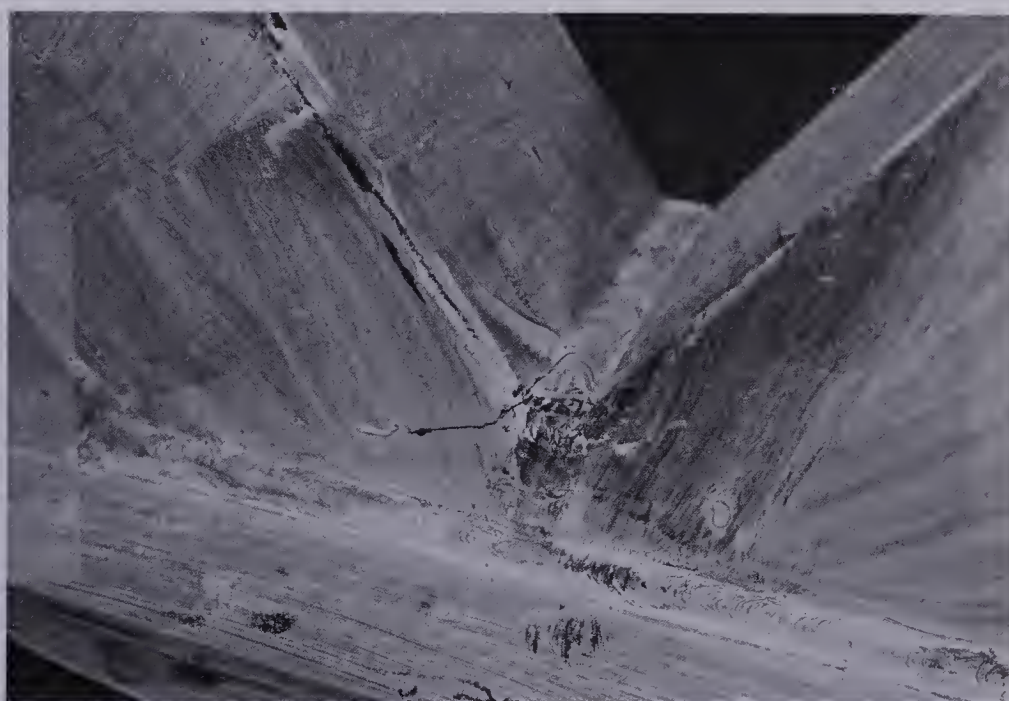
Figure 4.7 Crack at Joint L1 (T2F)

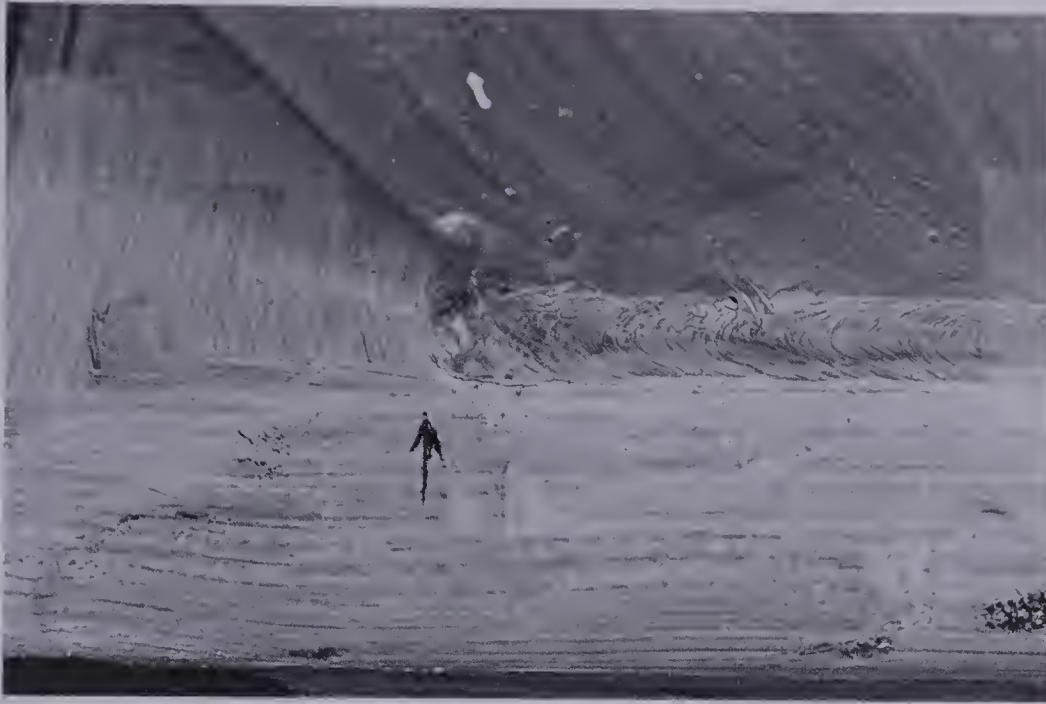
Figure 4.8 Crack at End of Member L1 U2

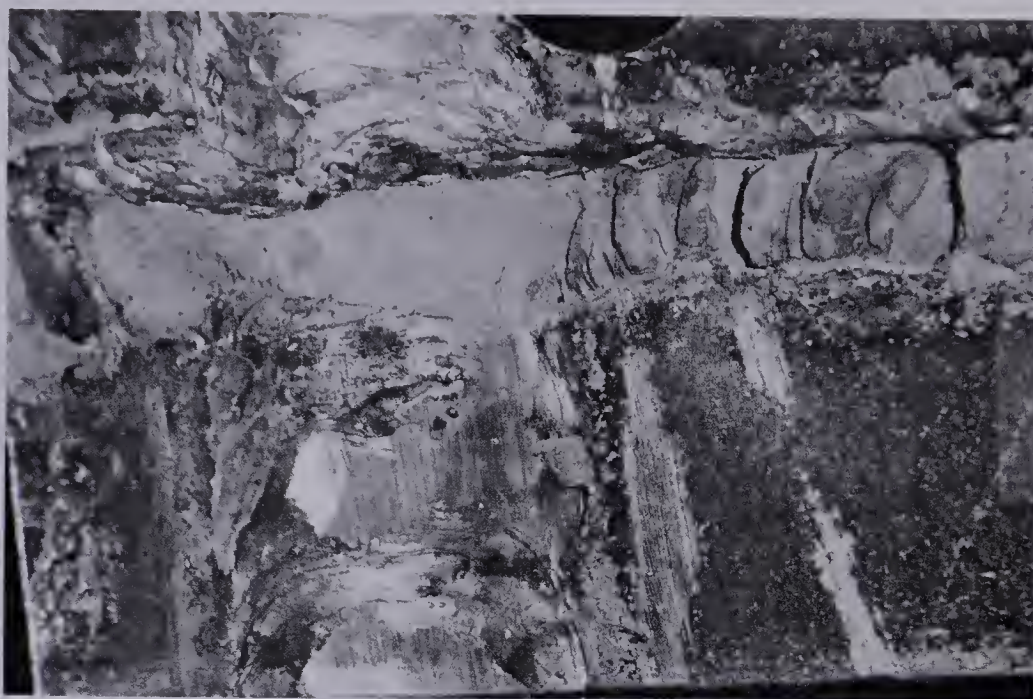
Figure 4.10 Fracture Surface of Crack (joint U2)

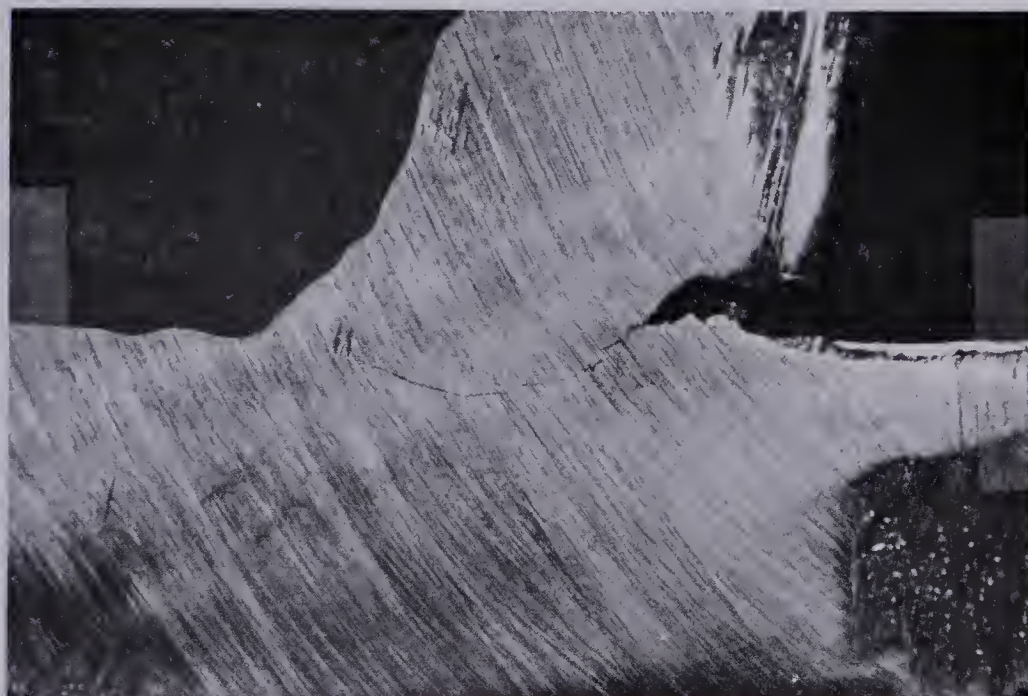
Figure 4.11 Crack Profile (joint U2)
